Failure Analysis and Evaluation of a Six Cylinders Crankshaft for Marine Diesel Generator

Khaeroman^{1,a)}, Gunawan Dwi Haryadi¹, R. Ismail¹ and Seon Jin Kim²

Abstract. This paper discusses the failure of a diesel engine crankshaft of a four stroke 6 cylinders, used in a marine diesel generator. A correct analysis and evaluation of the dimension of the crankshaft are very essential to prevent failure of the crankshaft fracture and cracks. The crankshaft is liable to deformation due to misalignment of the main journals bearings. This article presents the result of crankshaft failure analysis by measuring the mean diameter of the rod journal and the main journal, on the wear, out of roundness, taper, etc. The measurement result must be compared with the acceptable value in the engine specification and manual service and also should follow the American Bureau of Shipping (ABS) guidance notes on propulsion shafting alignment. The measurement results of this study show that the main journal diameter of the third cylinder exhibits an excessive wear, 1.35 % above the permissible lowest rate. It also has a taper for 0.23 mm and out of roundness of 0.13 mm. The diameter of the rod journal

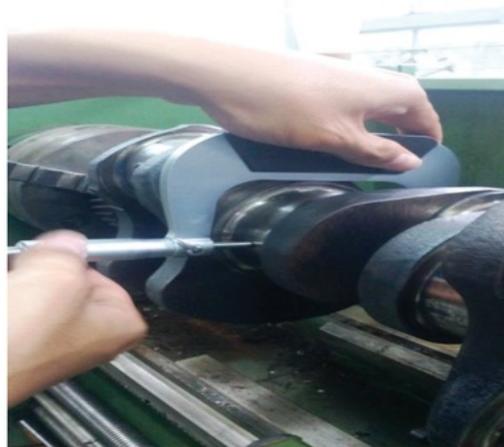
FIGURE 3. Measurement Diameter of Main Journal

Table 2 shows that all of the main journal diameters were experienced wear and showed that the main journal diameter of the third cylinder exhibits an excessive wear, 1.35 % above the permissible lowest rate.

Table 3 shows that most of the measurement results of the taper and out of roundness is more than the limit prescribed limits, especially for no.3 where the measurement value is highest among others.

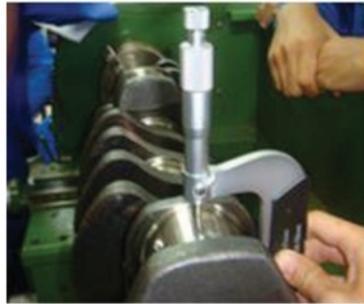
FIGURE 4. Measurement diameter of connecting rod journal

Table 5 shows that all of the connecting rod journal diameter were experienced wear and showed that the main journal diameter of the third cylinder exhibits an excessive wear, 1.06 % above the permissible lowest rate.

Table 6 shows that of the measurement results of the taper and out of roundness for no.3 is more than the limit prescribed limits.

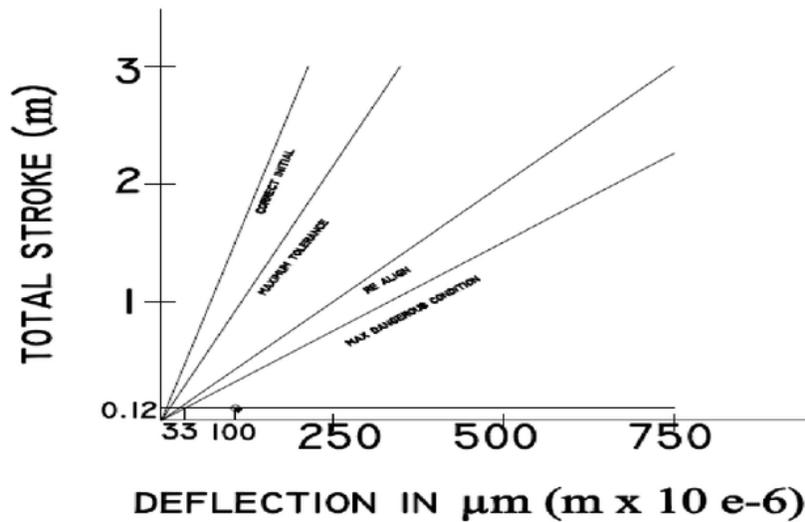
FIGURE 8. Crank Web Allowable Deflections [10]

To determine the value of crank web allowable deflection by looking in Fig. 9 is the piston stroke of 120 mm, the value of crank web allowable deflection of 0,033 mm or 33 μm . To see the results of Table 9, the value of deflection (vertical = T - B) on the cylinder No. 3 is 0,10 mm or 100 μm , where the value of this deflection is already at the maximum dangerous condition.
