# Failure Analysis of Shaft Circulating Water Pump (CWP) used in Power Plant

**Abstract.** Pump shafts are generally exposed to the liquid being pumped either on a continual basis or at certain locations along the length of the shaft. The shaft material is austenitic stainless steel, description ASTM AU 79 TY 316. The purpose of this study is to determine the failure of the water pump shaft used in the power plant. Metallography is the study of structure metal shaft can be used as a means for CWP metal pelleting (Circulating Water Pump), for the purpose of damaged or deeply degraded areas. SEM test is used to know the beginning of the crack (crack initiation). EDS test is used to chemical composition and Vickers hardness test is also used to know the hardness material. These three tests to support in analyzing the failure of the pump shaft. The conclusion of this failure analysis is the shaft material has porosity. Fatigue cracking comes from the outer surface area.

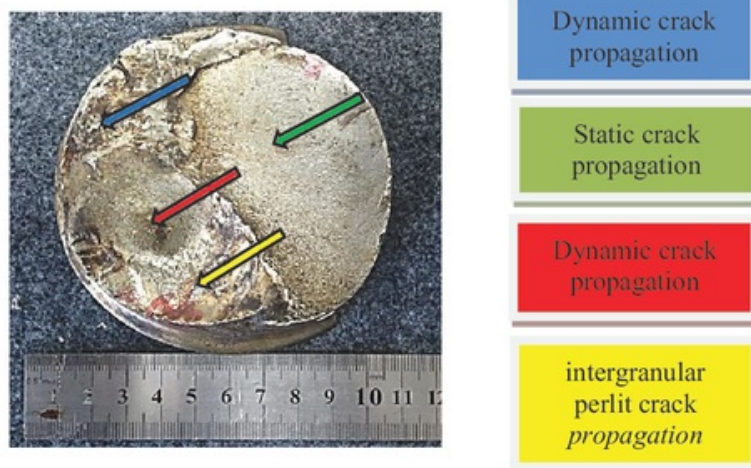
Visual examination of the failed end gave the appearance that the shafts of CWP failed by fatigue. A macroscopic view of the failed region of shaft is shown in Fig.3. Signs of smearing and distortion at the key edge were observed.

Areas of damage to the CWP shaft as fatigue failure. Crack propagation begins from an intergranular perlite gap in the yellow arrow. Dynamic layout is displayed on the blue arrow and the red arrow. Static cracking is a very quick propagation in green arrows. The area of damage to the shaft is shown Figure 3.

Fig 3. Sites of initiation of fatigue cracks indicated.

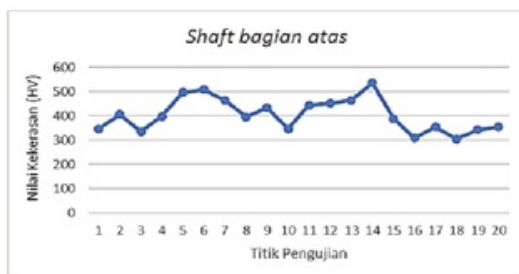
Regarding the hardness test, the top axle has a constant HV value and the failure shaft has a very high HV value. Hardness value of the upper shaft and failure shaft are provided in **Fig 4** and **Fig 5**. From the results of hardness testing (HV) obtained a very high abrasion hardness value this proves that the broken shaft fails because of the residual stress on the material. The residual stress causes the axis to be broken suddenly (unexpectedly).

**Fig 4.** Hardness value upper shaft.

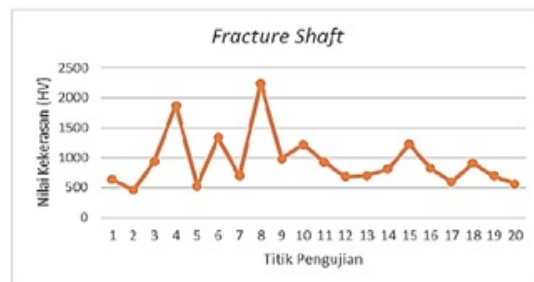
**Fig 5.** Hardness value failure shaft.

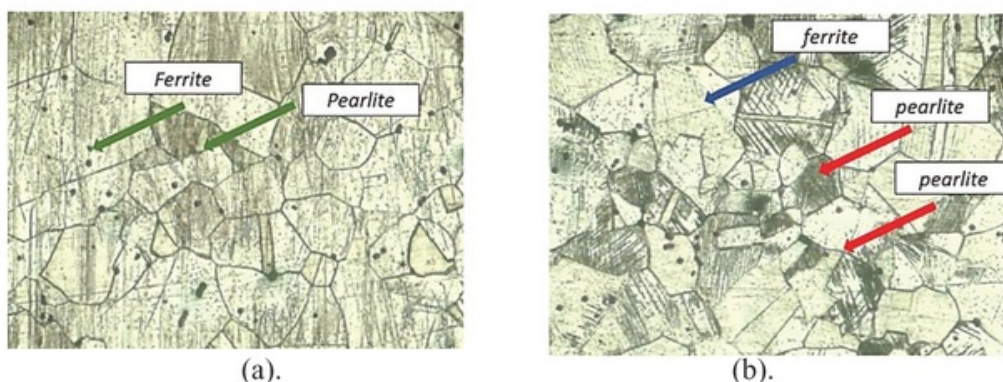
Metallographic test can be explained about microstructure type 316 with description description that type 316 is austenitic stainless steel chromiumnickel containing molybdenum. Type 79 TY 316 is an extra-low type 79 TY 316 carbon version that minimizes the precipitation of harmful carbides. With the influence of heat and rapid cooling rate, the pearlite structure is formed.

Figure 6 shows the microstructure of upper shaft and failure shaft. The failure shaft formed has new pearlite, its means that the failure shaft more hardness than the upper shaft.

**Fig 6.** Microstructure of upper shaft and failure shaft: (a) microstructure of upper shaft and (b) microstructure of failure shaft.

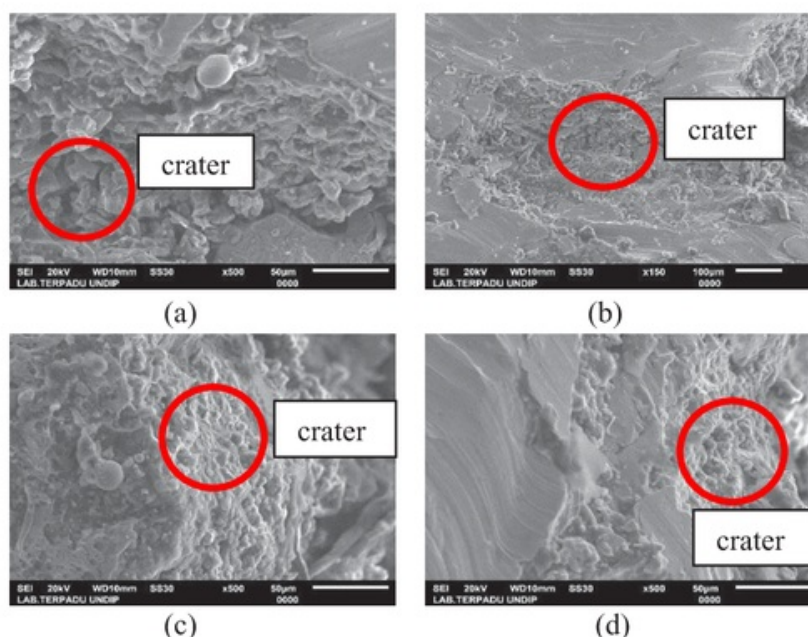
Scanning Electron Microscopy (SEM) is used to fractographic examination. The result of the SEM test we can see the area that became the initial reference of the beginning of the crack. The brittle fracture experienced by the failure shaft can be explained by the contour of a SEM photo marked by a circle, looking very rough because the area has a brittle and high hardness. Figure 7 shows the result SEM in initial crack.

Fig 7. The result SEM in initial crack (a, b, c, d).
