Lessons Learned from the Recent Natural Disasters in Indonesia

Sri Prabandiyani Retno Wardani and Agus Setyo Muntohar

4.1 Introduction

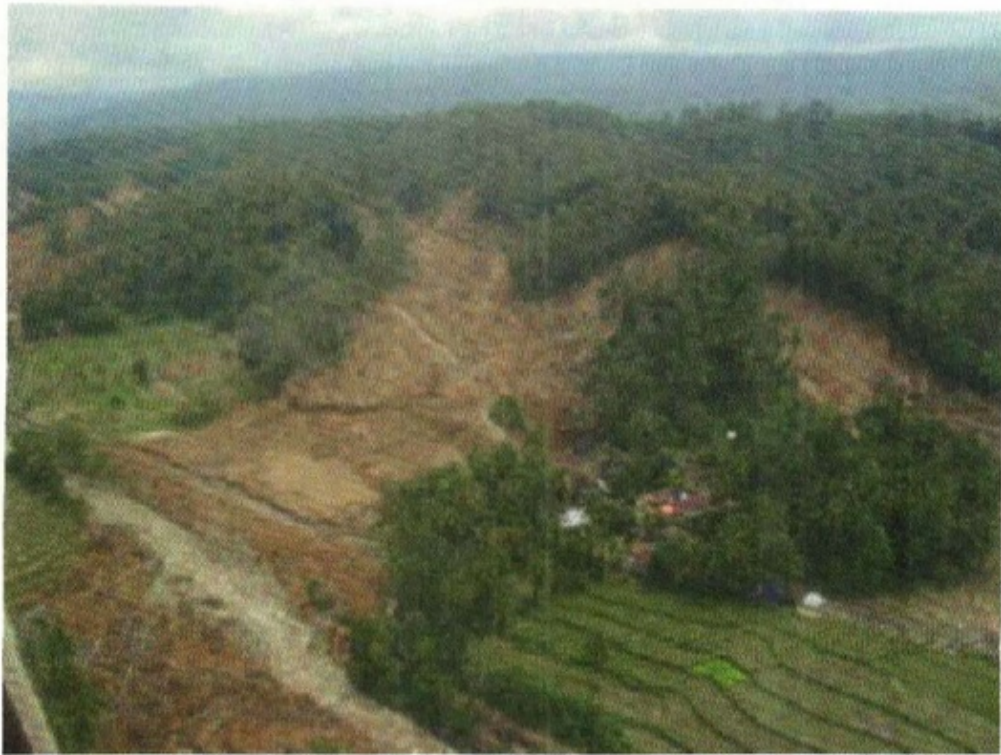
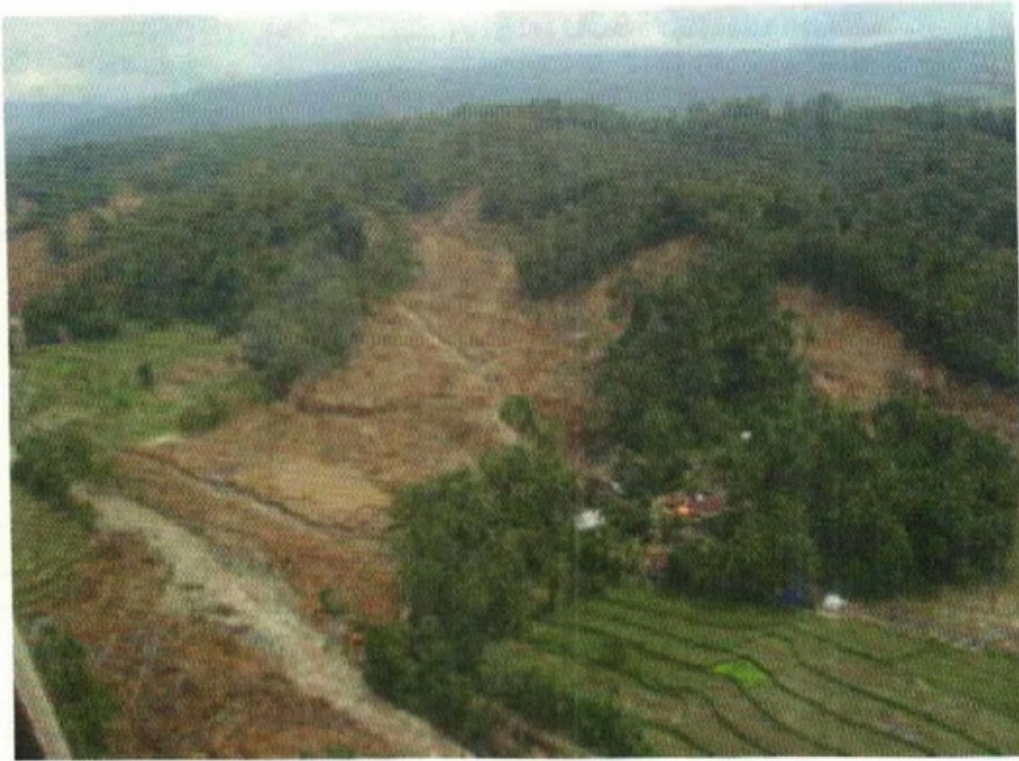
The shaking ground induced landslides and subsequently collapsed slopes at various spots in the mountain areas. As a result, many access roads were cut off, thus creating a significant amount of time to grasp the damage in the affected areas. Extensive landslides in Padang Pariaman resulted in high casualties; three small villages were buried (Fig. 4.5). Observations of the spoil site showed that the pumiceous tuff originating from late eruptions of the Maninjau caldera was light and porous and had little cohesion. Heavy rain over several days before the earthquake probably saturated the ground, increasing the driving force and

weakening the soil resistance, causing the slope to be marginally stable. The flat lands below the hills at the toe of the hills, consisting mainly of loose silt, sand, and gravel mixtures, may have also lost lateral support and contributed to the massive landslides as well as debris and mud flows (Fig. 4.6). In highland areas, the heavy rain and earthquake caused near-surface loose colluvium to slide (EERI 2009).

Fig. 4.5 Massive landslides occurred in Pariaman: a village below this slide was buried

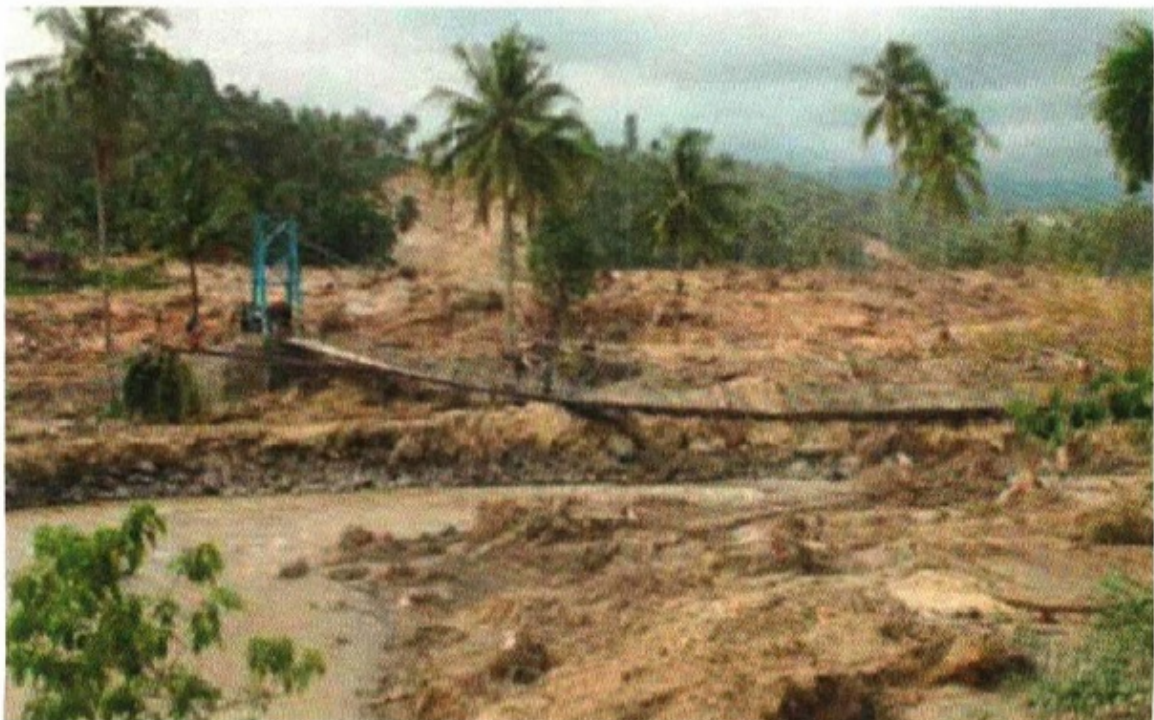
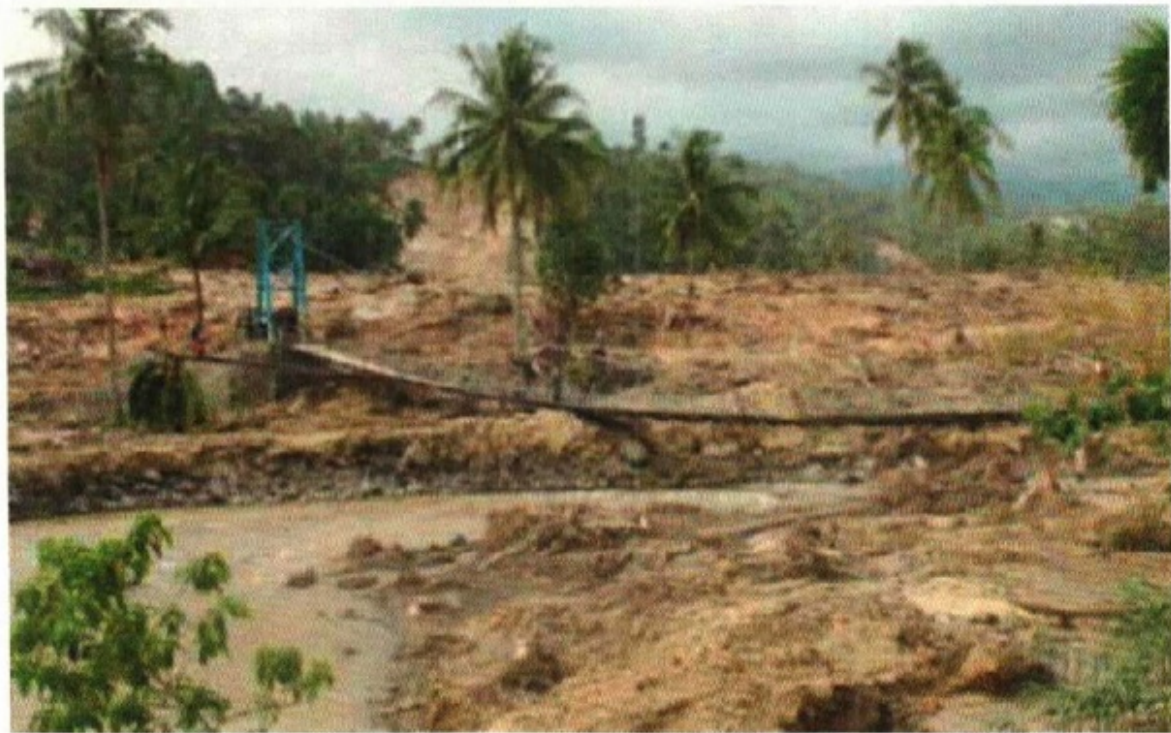
Fig. 4.6 Debris flows in rural areas northeast of Pariaman

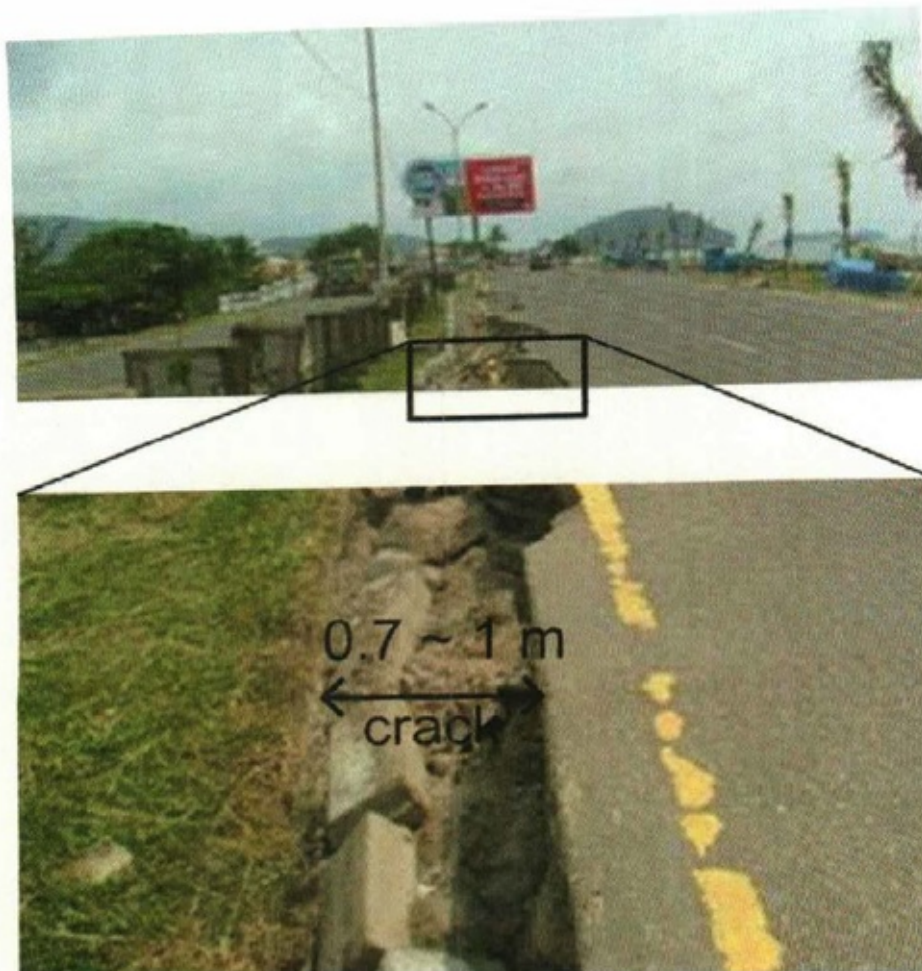
Liquefaction occurred during the quake. ⁵ Ground amplification of the seismic waves, which was particularly damaging to taller buildings, was reported with a longer natural period. Eyewitnesses described visible ground waves from the earthquake. Most liquefaction and lateral spreading were observed at the area near the coast (Fig. 4.7).

Fig. 4.7 Lateral spreading affecting the Seafront road (Jalan Samaudra) in Padang

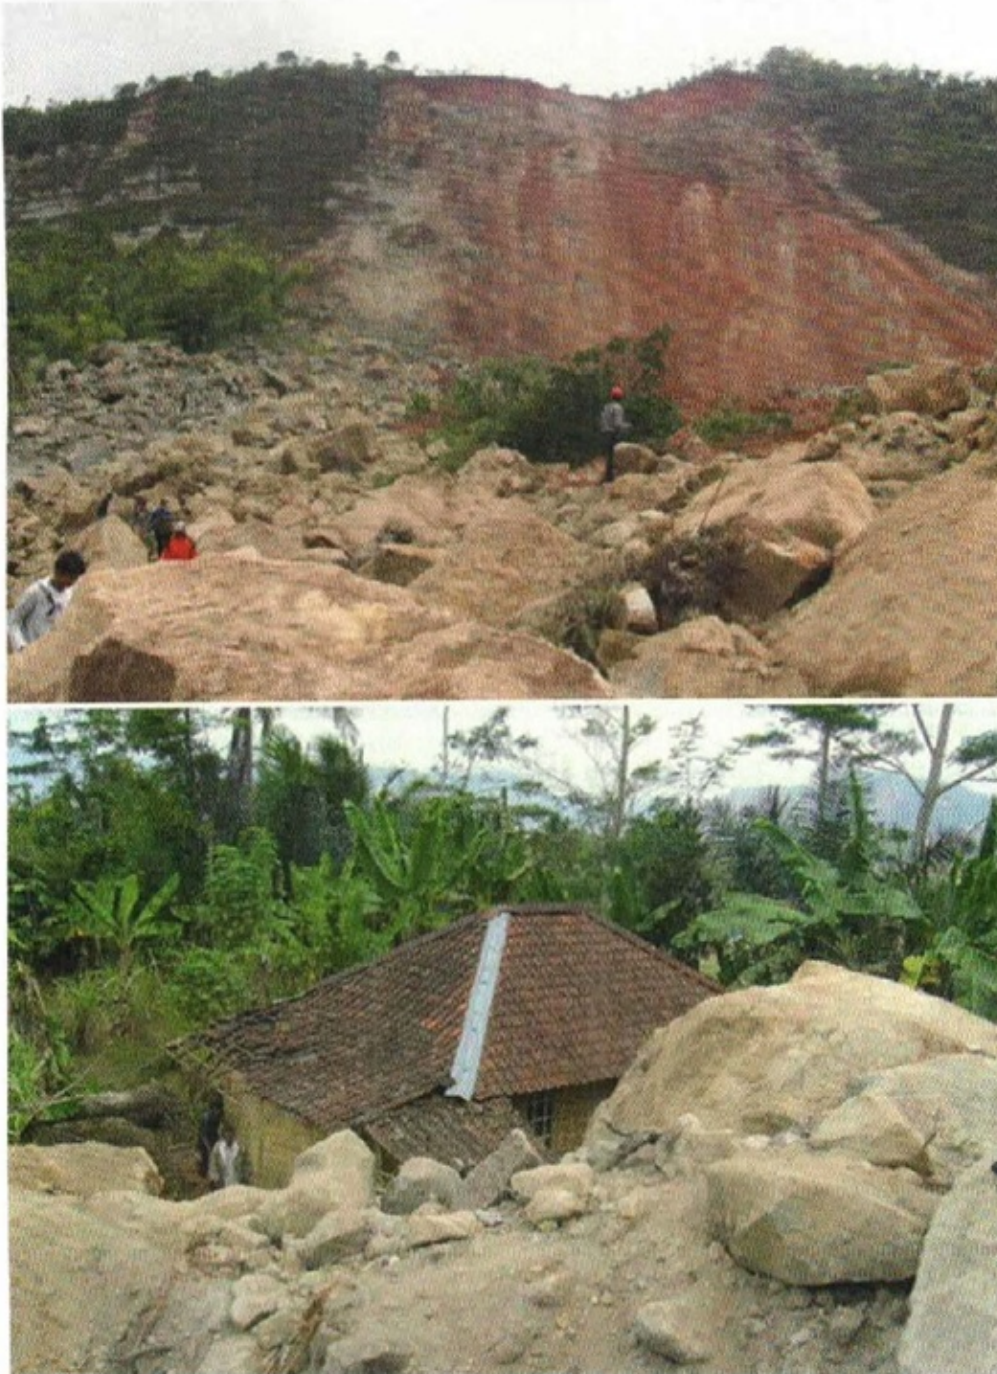
An earthquake induced a huge landslide at Cikangkareng; it buried 12 houses and killed 30 people (Fig. 4.10). The slopes of the region were very steep, about 80–90°, whereas the village was located near the slope. The geologic setting of the region was formed with sedimentary rock that consists of sandstone, tuff, and breccias (Koesmono et al. 1996). During the dry season, the rock weathered and

Fig. 4.10 Landslide induced by earthquake at Cikangkareng, Cianjur: landslide source (*top*); rock debris materials covered village (*below*)

resulted in sandy silt and sandy clay. A joint was formed and a fissure was found near the ground surface. Consequently, the slopes collapsed easily during ground shaking when the earthquake occurred on September 2, 2009. Landslide materials such as rock and earth fall and flow quite fast and ruin villages (Fig. 4.10).

It can be learned from the massive landslides in Pariaman and Cingkakareng that the community must be aware of and understand collateral disaster risk. The recent earthquake also pointed out the lack of an earthquake-induced landslide early

warning system (ELEWS). At the moment, the community and government focus on a rainfall-induced landslide early warning system. Hence, an integrated landslide warning system needs to be built.

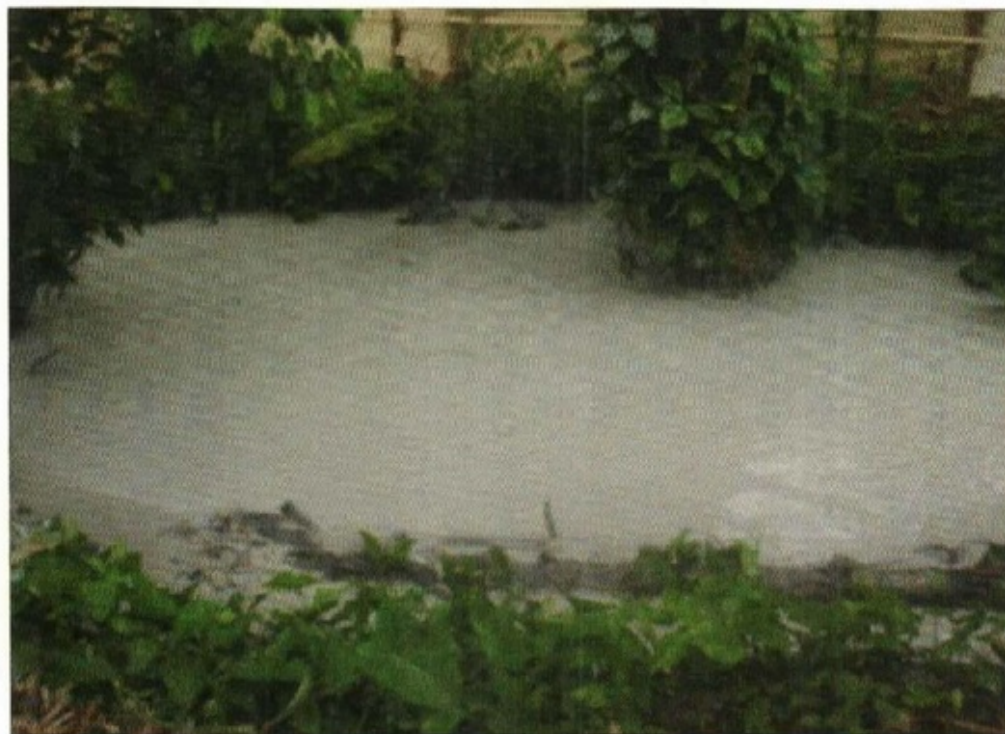
Liquefaction occurred during the earthquake. The ground shaking triggered mudflow at Pasir Gede, Sukahening village (Fig. 4.11). The area is located at $S07^{\circ}12'34,6''$ and $E108^{\circ}08'08,7''$. Based on interviews of local people, similar

Fig. 4.11 Sand boiling at Kp. Pasir gedc, Sukahening village, Sukahening, Tasikmalaya

mud flows occurred in 1952 and 1982. According to the geology map (Budhitrina 1986), the mud flow location was laid on volcano sediment, breccia, lahar, and tuff underlain with andesite and basalt from the Talagabodas volcano. There was no fault observed in the mud flow region. However, the quake was possibly caused by a shear joint adjacent the aquifer layers. As a result, the gray color of mud flowed out with water because of pressure from the aquifer.

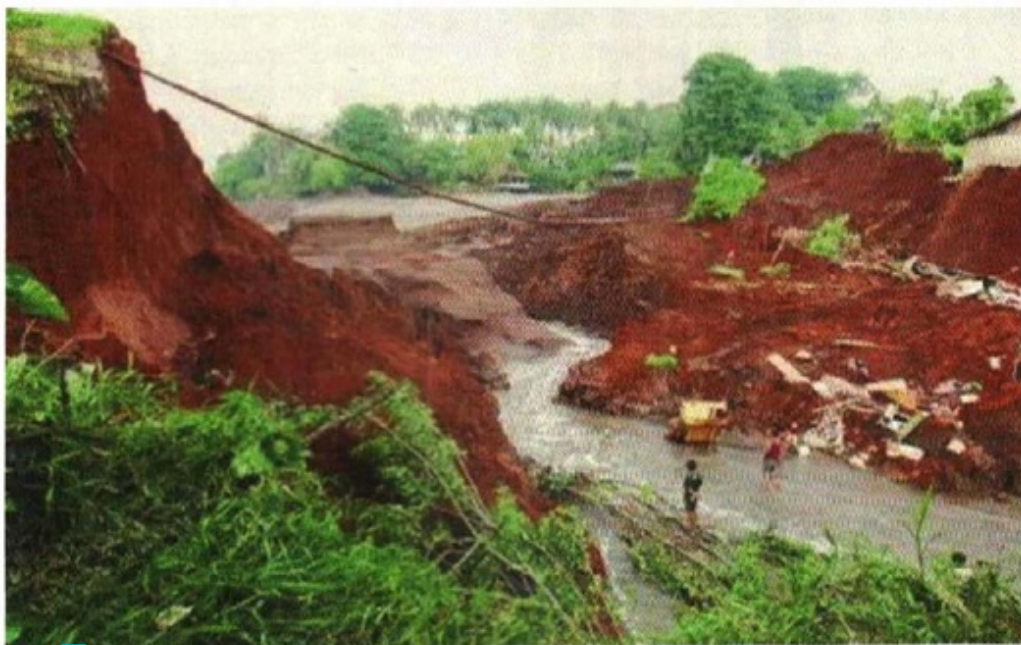
On Friday morning, March 27, 2009, at 2:00 a.m., the Situ Gintung dam burst in Cirendeu, Ciputat, Tangerang, Banten Province (Fig. 4.12). The dam failure was triggered by torrential rains. The water in the reservoir, about 15-m wave of water, flushed into houses and villages downstream (Fig. 4.12). The dam was originally built by Dutch colonial authorities in 1933. It was made from earth compacted into a wall 16 m high, and the reservoir held at least two million cubic meters of water. The original imperative of the dam had been to retain water for irrigation of rice paddies, which were subsequently replaced by urban development.

Heavy rain was indicated as the triggering factor for the dam failure. On March 26, 2009 at 4.00–7.00 p.m., the nearest rainfall station in Ciputat (Balai II) recorded a rainfall duration of about 4 h, with accumulated rainfall of about 113 mm (BMKG 2009). The rainwater caused the water level in the reservoir suddenly rise. However, overflow of the water could not spill out through outlet tunnel because the spillway and outlet malfunctioned. Consequently, the water overtopped the crest of the earth dam. The overtopping caused some piping and cracks at the toe downstream of the dam. The piping allowed water to infiltrate the capillary breaks that caused the dam to collapse. Piping was also identified by eyewitnesses in December 2008.

4
Fig. 4.12 Collapse of the Situ Gintung dam on March 27, 2009

The area surround the Situ Gintung dam has developed into a populated settlement. According to the spatial planning law of the Republic of Indonesia No. 24/1992 or the current spatial planning law No. 26/2007, the Situ Gintung area is supposed to be a conservation area. Assigning the Situ Gintung area as a conservation area means only activities protecting the environmentally sensitive area of Situ Gintung

To reduce disaster risk, mitigation has to be implemented continuously. Many dams in Jakarta and other regions are also located in heavily populated areas. An early warning system (EWS) has to be built to reduce the risk. An EWS includes routine maintenance of the dam, improving land use, and spatial planning, empowerment, and participation of the local society (Fig. 4.13).
