Investigation on Centrifugal Pump Shaft: A Comparison Study of the SME and the Imported Product

Rifky Ismail, Sugiyanto, Mohammad Tauviqirrahman and Jamari

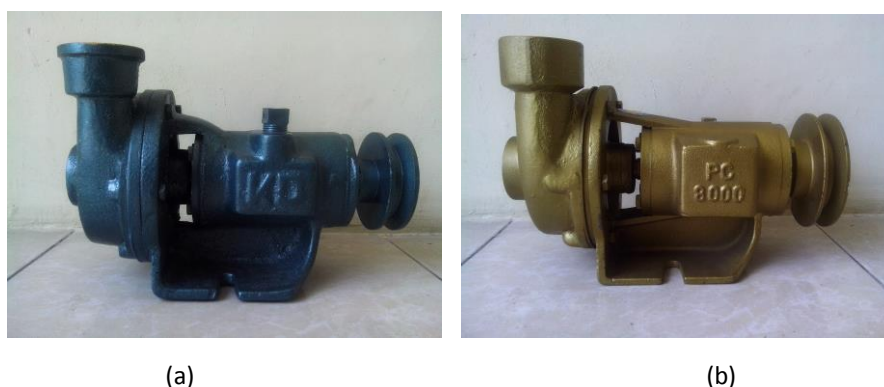
Figure 1. A pump for a fisherman ship: (a) made by SME and (b) imported product.

The implementation of the ASEAN-China Free Trade Agreement (ACFTA) forces the small and medium enterprises to have a high competition between the manufacturer from China and the ASEAN member countries. One of the competitions occurs on the market of centrifugal pump for fisherman ship. The pump, made by small and medium enterprises (SME) in Tegal, Central Java, has a lower price but also has a short lifespan. The imported product, comes from Malaysia, is now preferred by the fisherman due to its reliability performance and its longer lifespan. The price of the imported pump is three times higher than the SME product but it has an optimal operation time 4-5 times longer. Figure 1 depicts the pumps made by SME and the imported product.

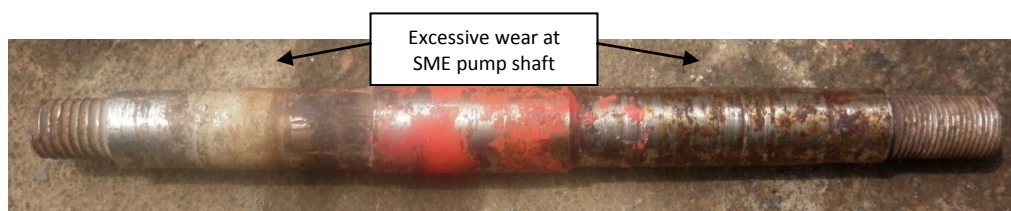
Figure 3. The failure of the shaft of the fisherman ship pump after three months operation.

The main issue in this paper is the fail of the SME pump shaft in maintaining its good performance during transmitting the power from the engine to the water impeller. The fail of the SME pump shaft is indicated by the excessive wear on the bearing track on the left and right sides of the shaft. Initially, the researchers diagnose that the material in SME pump shaft had a low quality and did not support to receive the radial load along the bearing tracks. This initial diagnosis is then rejected by the experiment facts that the chemical compositions, the tensile
