THE INTEGRATION OF CLIMATE CHANGES ADAPTATION AND MITIGATION IN SUSTAINABILITY CONCEPT

S.P.R. Wardani ^{1),2)}, Bagus Hario Setiadji ^{1),2)},, Harsono Wuryanto ¹⁾
Muhammad Zaki ²⁾

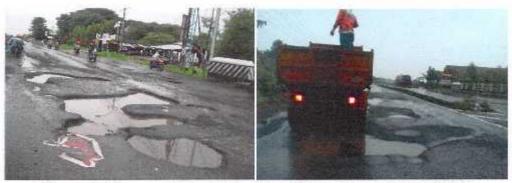
Figure 3. Damaged Roads after Flood (Bina Marga Jateng, 2014)

Figure 3 shows that the major damage after flooding on the road is the presence of potholes or road surface stripping. The potholes occurred generally begins in the form of small ones or cracks. The occurrence of potholes in the road surface due to the loss of aggregate during flooding, or transported at the time of the vehicle wheels running through.

Through the cracks on the road surface, the water will infiltrate pavement structure, and slowly diminish the adherence between asphalt and aggregate. If water is found under surface layer, it could weaken the carrying capacity of the foundation layer and leading to other distresses such as depression, rutting, and so forth.

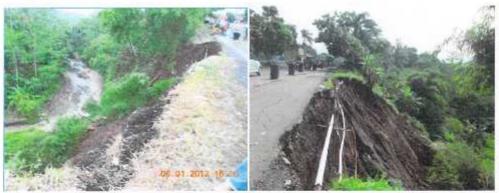
Figure 4. Landslides at Several Sites in Central Java Province (Bina Marga Jateng, 2014)

Another hazard that may occur in the presence of high rainfall is the landslide. It is often occur especially at mountainous terrain and marginally unstable slope with the absence of slope stabilization efforts, such as providing horizontal drain, structural wells, piles or reinforced ground, and so on. Landslide is very highly hazardous, especially if there is road infrastructure over the terrain as it inflicts many casualties and potential economic loss due to traffic disturbances. Figure 4 depicts the landslides at several sites in Central Java Province (Bina Marga Jateng, 2014).
