Failure Analysis and Evaluation of a Six Cylinders Crankshaft for Marine Diesel Generator

Khaeroman^{1,a)}, Gunawan Dwi Haryadi¹, R. Ismail¹ and Seon Jin Kim²

Abstract. This paper discusses the failure of a diesel engine crankshaft of a four stroke 6 cylinders, used in a marine diesel generator. A correct analysis and evaluation of the dimension of the crankshaft are very essential to prevent failure of the crankshaft fracture and cracks. The crankshaft is liable to deformation due to misalignment of the main journals bearings. This article presents the result of crankshaft failure analysis by measuring the mean diameter of the rod journal and the main journal, on the wear, out of roundness, taper, etc. The measurement result must be compared with the acceptable value in the engine specification and manual service and also should follow the American Bureau of Shipping (ABS) guidance notes on propulsion shafting alignment. The measurement results of this study show that the main journal diameter of the third cylinder exhibits an excessive wear, 1.35 % above the permissible lowest rate. It also has a taper for 0.23 mm and out of roundness of 0.13 mm. The diameter of the rod journal

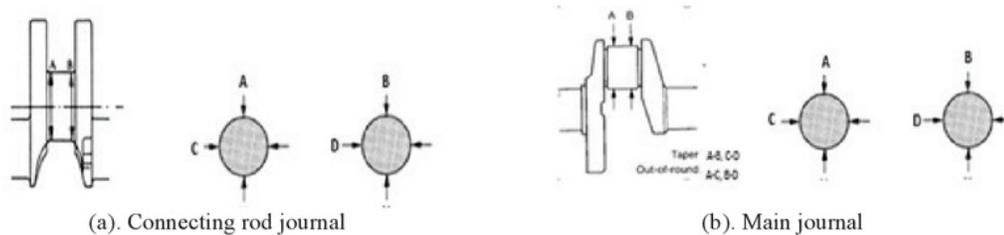
FIGURE 1. Measurement Point of Connecting Rod and Main Journal [5]

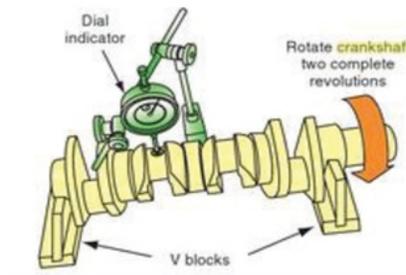
FIGURE 2. Warpage / Runout Measurement [6]

Figure 3 shows that the examination of warpage on this method by using a dial indicator with stand. Installation of the crankshaft lathes has also done the alignment of the crankshaft position prior to this warpage measurement. Warpage Measurement is not only done in the middle of the crankshaft but carried on each main journal.

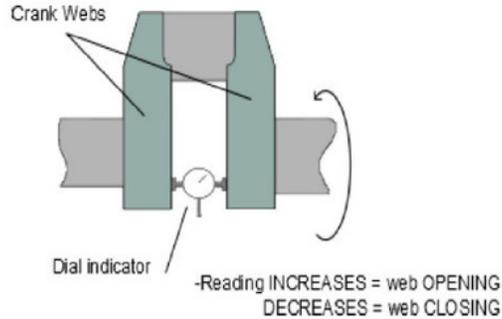
Crank web deflections are an indirect confirmation of the stress level in the crankshaft. However, the crank web deflections can be utilized as an indication of the crankshaft bearing loading as well. The crank web deflections are important to be verified as a part of the alignment procedure. Therefore, when the alignment procedure is performed, and if the bearing offset is changed, the crank web deflections need to be confirmed to be within the engine manufacturer-required limits [7-9]. Crankshaft deflection measurement is conducted with a dial indicator being placed at a predefined location between crank webs. The crankshaft is then rotated, and the readings are taken at the prescribed angular locations. Web deflections between each cylinder are measured. Crank web allowable deflection is 0.033 mm.

FIGURE 6. Dial Indicator to Check Crank Web Deflection [8-9]

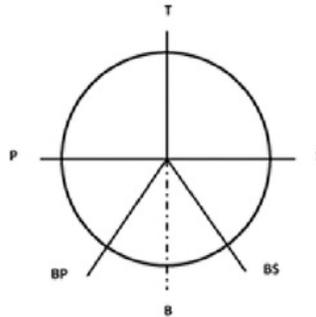
FIGURE 7. Measurement Point of Crank Web Deflection [10]

To determine the value of crank web allowable deflection by looking in Fig. 9 is the piston stroke of 120 mm, the value of crank web allowable deflection of 0,033 mm or 33 μm . To see the results of Table 9, the value of deflection (vertical = T - B) on the cylinder No. 3 is 0,10 mm or 100 μm , where the value of this deflection is already at the maximum dangerous condition.
