# Morphological Study of Epoxy Resin after Electrical Tracking

**Abstract**—Currently, epoxy resin has been developing as outdoor insulator replace ceramic and glass insulator, because epoxy resin has some dielectric properties better than the ceramic, glass and porcelain material. When epoxy resin was used as outdoor insulator, some factors affecting performance of epoxy resin insulators are like rain, humidity, ultraviolet rays, condensation and contaminant. To improve the surface properties of epoxy resin, then silicon rubber material that has the ability to repel water were added and silica sand was mixed with silicone rubber to improve the mechanical properties. When contaminant flows at the insulator surface, they can cause damage to the surface of the insulator and it was formed tracking on insulator surface and finally cause flashover.

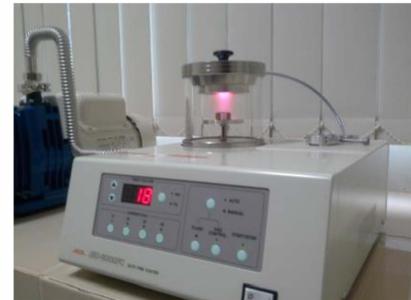
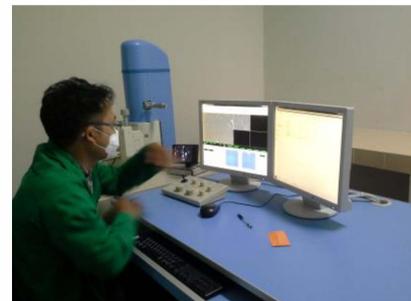
Fig. 6. Detect of imaging SEM; a) coating processes; b) Taken place of Image with SEM monitor

SEM imaging was conducted in Laboratorium Terpadu, Diponegoro University. Each test samples must be coated by platinum for SEM imaging. SEM image processes in Laboratory is shown in Fig 6 as follow:
