Study on Tracking Time of Epoxy Resin Insulating Material under Artificial Accelerated Aging

Abstract— An insulator installation in tropical climate and high rainfall areas could cause a problem. Humidity and rain take an essential role in filling insulator wet surface which produces contaminant and leakage current flowing on it. Besides, continuous ultraviolet radiation will accelerate the aging and degradation process on the insulator surface which also make electrical current easy to flow. This research discussed the effects of ultraviolet radiation and fly ash addition as a filler material toward contact angle, tracking time, and the average leakage current value of high voltage insulation of epoxy resin materials. This research was done on a laboratory scale using epoxy resin polymer materials (DGEBA and MPDA) mixed with silicone rubber and fly ash with filler composition variation of 20%, 30%, and 40%. Samples were flowed by rainwater contaminant with conductivity of 196 $\mu\text{S}/\text{cm}$, NH_4Cl with resistivity of $3,95 \pm 0,05 \Omega\text{m}$ and it also were already given ultraviolet radiation in 0, 24, 48, 72, and 96 hours. Leakage current values was obtained by

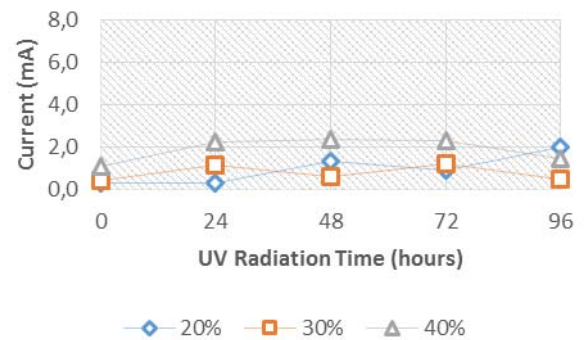
a) Characteristic of Leakage Current with Rain Contaminant
After conducting all measurements, the average leakage current values could be observed in Fig.9.

Fig. 9. Chart of the average leakage current value contaminated by rainwater

The measurement results indicated that the longer the ultraviolet radiation given on samples, the bigger the average of leakage current values. Fig.9 showed that the graph was inconstant because of the inhomogeneity samples making caused by limited material printing devices. Inhomogeneity samples making resulted in emerging of air cavity in stirring process so there was such different quality of testing samples. During the ultraviolet radiation, there were heating and oxidation processes which caused the occurrence of chemical

The addition of filler material also affected the average of leakage current values. The average leakage current of RTV₂₃ sample in UV Radiation of 48 hours was 0,598 mA. It was the lowest value of all samples, in which RTV₂₂ and RTV₂₄ got 1,354 mA and 2,371 mA respectively. The addition of filler material functioned to fix the characteristic of epoxy resin from hydrophilic to become hydrophobic, but the excessive addition would result in a declining of hydrophobic characteristic of testing samples surface. The more hydrophobic a material, the higher the resistivity. Testing material resistivity influenced the current flowing on the surface because the current only flowed on the parts with low resistance.

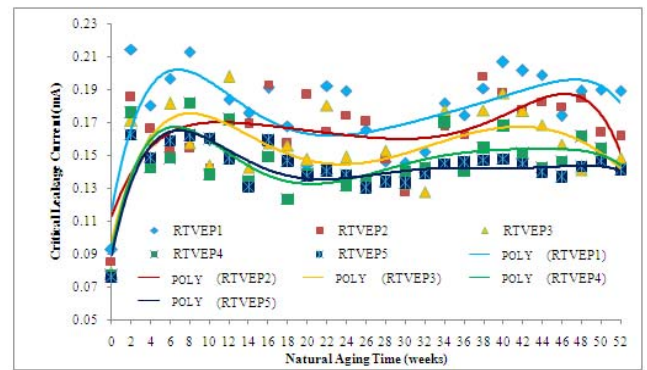
Fig. 11. Critical leakage current on insulator surface with filler composition variation in a natural aging of 52 weeks [11]

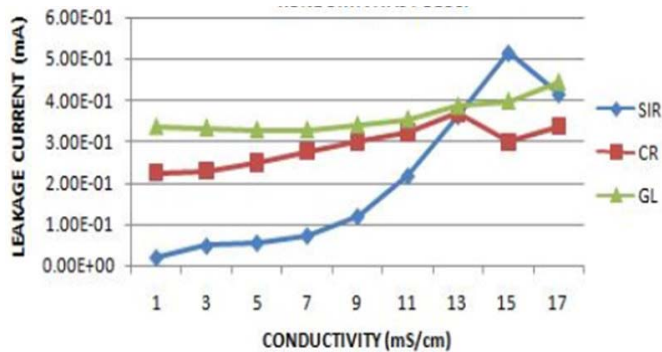
Fig. 14. Leakage current curve of SIR polymer insulator under the influence of salt conductivity [9]

Thus, it proved that conductivity could influence the time when insulation failure occurred. Meanwhile, figure 14 proved that the increase of conductivity and tracking time was inversely proportional.
