Experimental Investigation on Electrical Tracking of Epoxy Resin Compound with Silicon Rubber

Abdul Syakur¹, Hamzah Berahim¹, Tumiran¹, Rochmadi²

Abstract: The use of polymer materials as electrical insulators on transmission and distribution lines has been increasing such as epoxy resin. Several advantages of using epoxy resin as an insulating material are its low density, better dielectric properties, and epoxy resin has higher volume resistivity than that of the glass and porcelain. However, epoxy resin has some disadvantages when it is used in tropical areas concerning with the humidity, high ultraviolet radiation, acid rain and effects of contaminants. Consequently, insulator surface will be easily damaged due to electrical tracking, which is indicated by the surface tracking. In this paper, the surface tracking on epoxy resin compound with silicon rubber has been investigated. The test was done based on the method of Inclined-Planed Tracking (IPT) IEC 587:1984 with NH_4Cl as contaminant. The test materials used were epoxy resins based on Diglycidyl Ether of Bisphenol A (DGEBA) and Methaphenylene Diamine (MPDA) compound with silicon rubber (SiR) with the dimensions of 50 mm

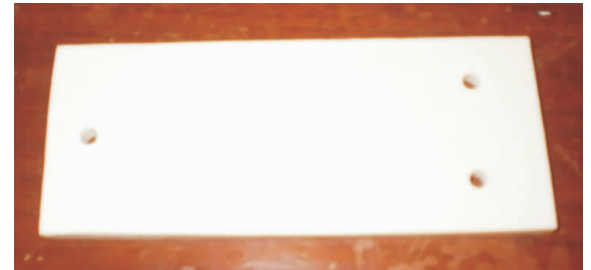
Fig. 3 Physical view of test sample and schema of test sample and its dimension

(a) physical view of test sample

(b) schema of test sample and its dimension

The samples were prepared in the form of blocks with the dimension of 50 mm × 120 mm × 6 mm. Test samples should be drilled to place electrodes as illustrated in Fig. 3 (a) and (b).

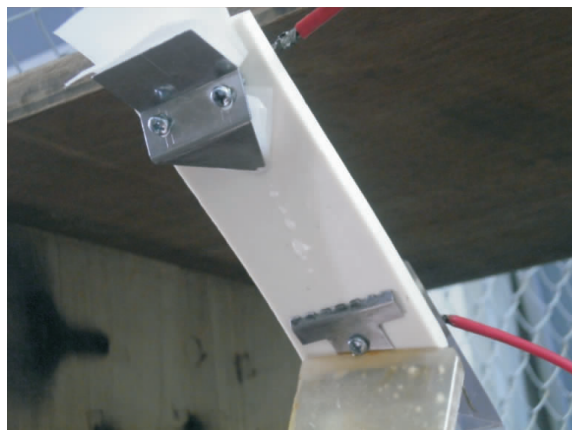
Fig. 7 Arrangement of electrode, filter paper and sample

Discharge current will be read and recorded by Oscilloscope in time of discharge on the surface of the material. Measurement data in the form of discharge current and discharge time of the first occurrence are then stored and will be used to analyze the surface condition and the effect of contaminants on the electrical tracking processes in the surface of insulation. The arrangement of electrode, filter paper and sample is shown in Fig. 7.
