Experimental Investigation on Electrical Tracking of Epoxy Resin Compound with Silicon Rubber

Abdul Syakur¹, Hamzah Berahim¹, Tumiran¹, Rochmadi²

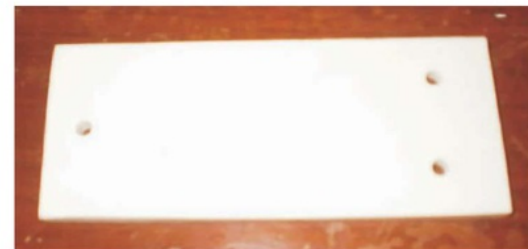
Fig. 3 Physical view of test sample and schema of test sample and its dimension

(a) physical view of test sample

(b) schema of test sample and its dimension

The samples were prepared in the form of blocks with the dimension of 50 mm × 120 mm × 6 mm. Test samples should be drilled to place electrodes as illustrated in Fig. 3 (a) and (b).

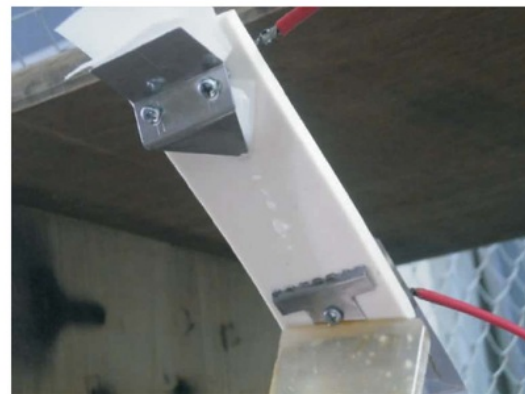
Fig. 7 Arrangement of electrode, filter paper and sample

Discharge current will be read and recorded by Oscilloscope in time of discharge on the surface of the material. Measurement data in the form of discharge current and discharge time of the first occurrence are then stored and will be used to analyze the surface condition and the effect of contaminants on the electrical tracking processes in the surface of insulation. The arrangement of electrode, filter paper and sample is shown in Fig. 7.

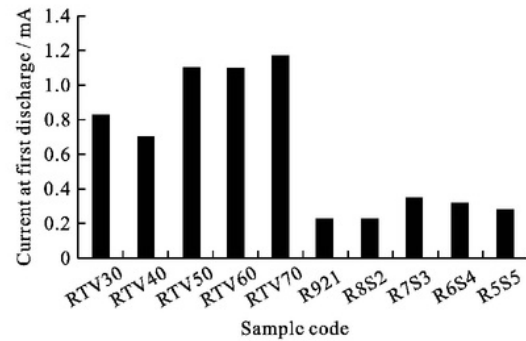
Fig. 11 current at the first discharge

Fig. 11 shows the first discharge currents in epoxy resin with and without silicone rubber. Based on Fig. 11, the first discharge currents in epoxy resin without silicone rubber is higher than with silicone rubber.

This indicates that the silicone rubber affect discharge current that occurs in the process of tracking surface.
